FIRST UNITARIAN CHURCH OF PROVIDENCE One Benevolent Street Providence, Rhode Island 02906

> 24 JUNE 2023 Rev. 24 July 2023 Rev. 30 July 2023

THE 1968 M.P. MÖLLER PIPE ORGAN

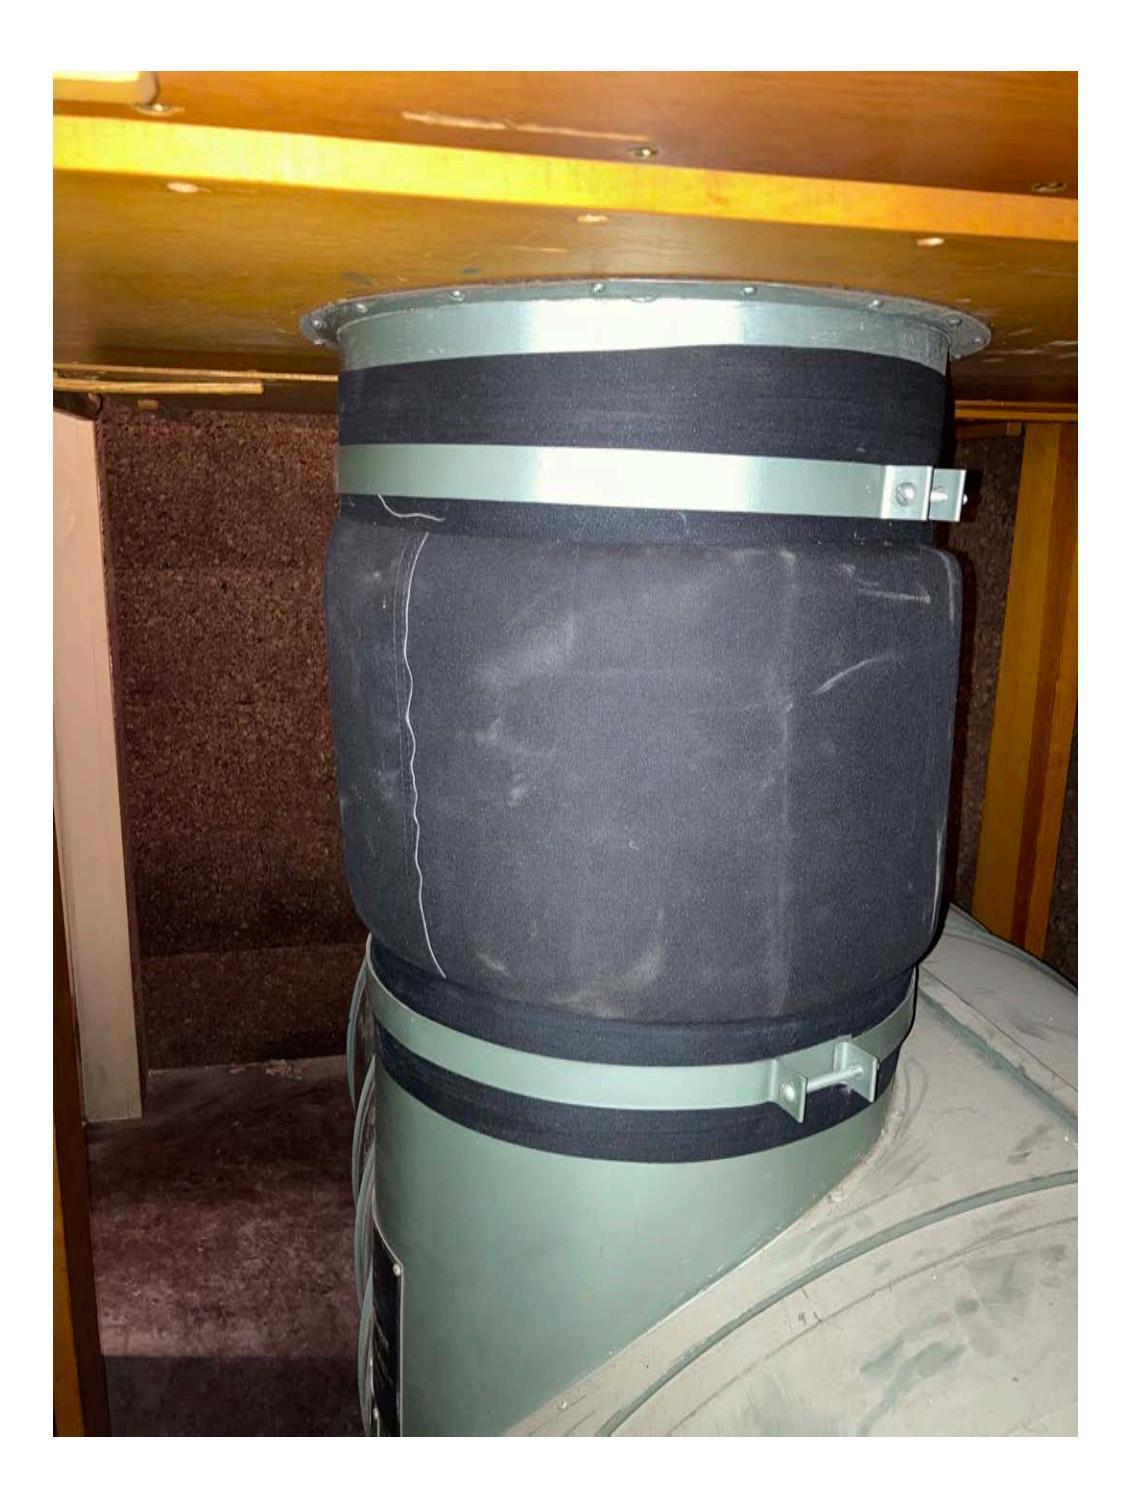
A sleeve of rubber-cloth, similar to the material used in automobile convertible tops, connects the blower to the wind distribution system. When that sleeve fails, as it did several months ago, the organ hemorrhages wind and nothing works or sounds properly.

Seen here is the new rubber-cloth sleeve Jonathan Ortloff fitted several months ago. It is affixed with friction tape, and additionally secured with metal bandclamps, to guard against failure.

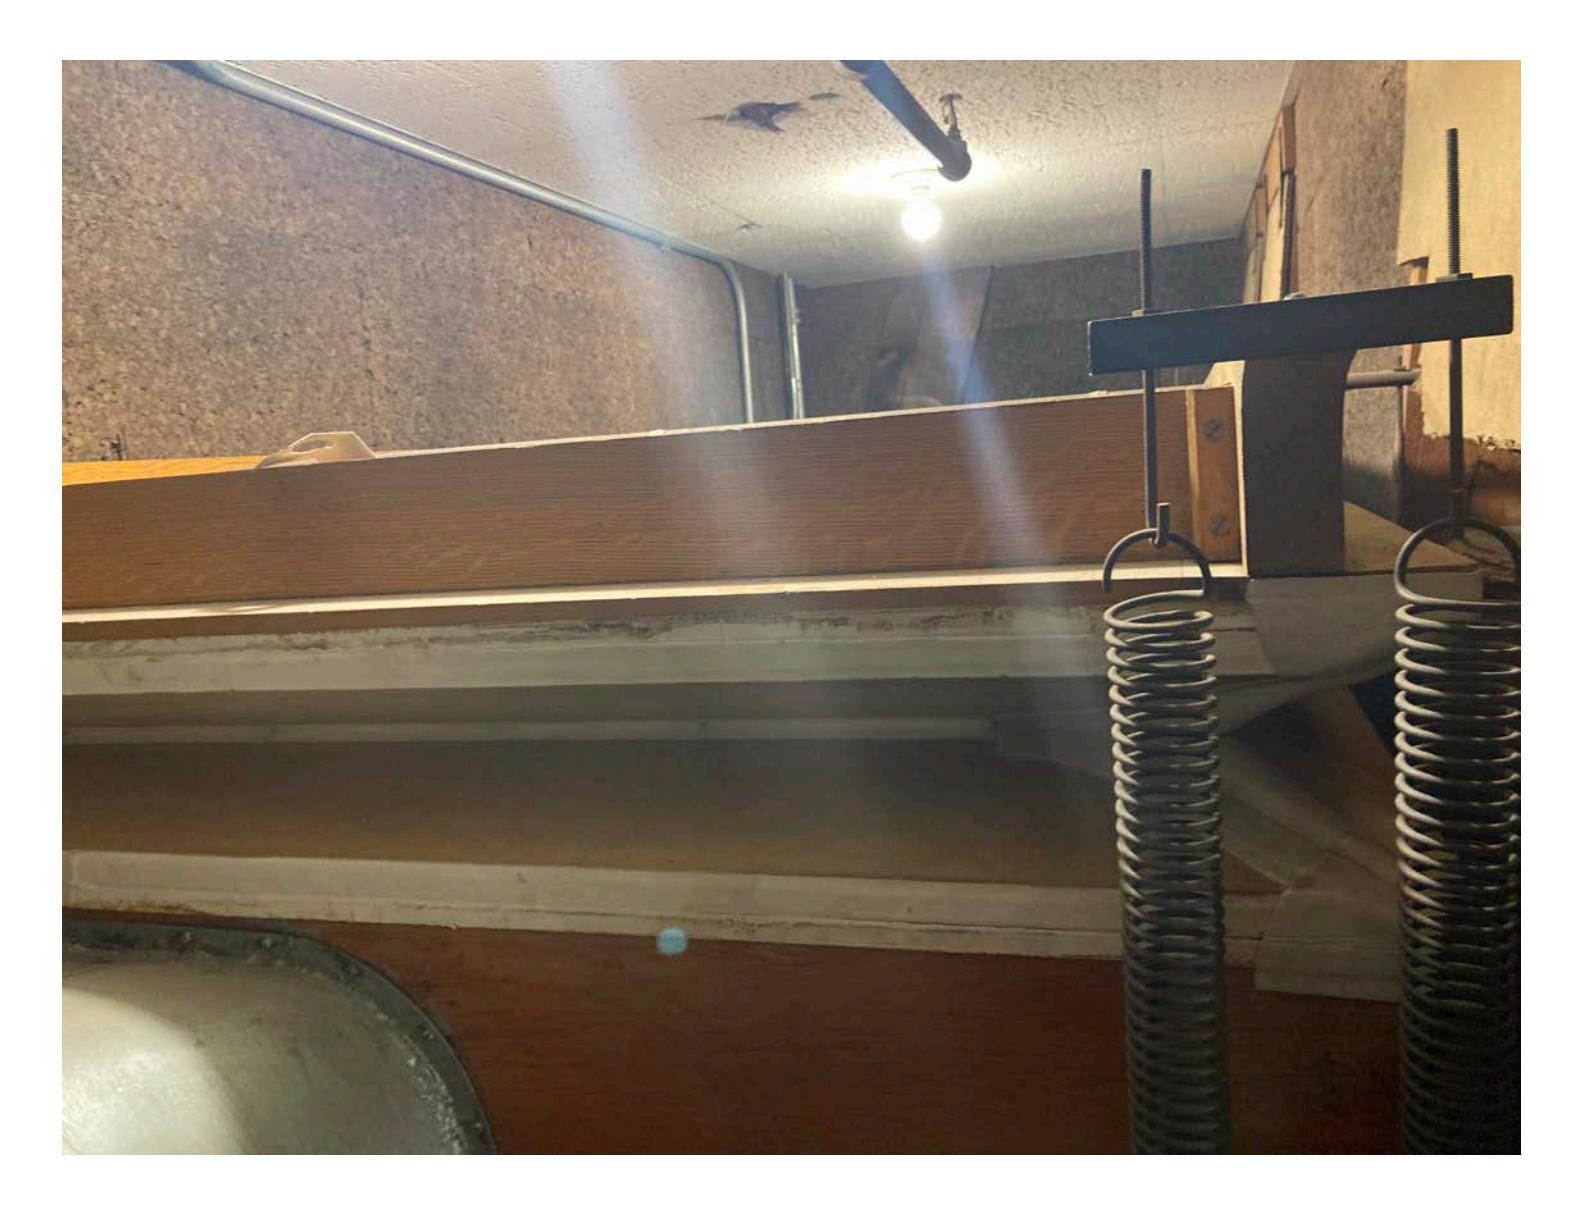
Above the blower, a large preliminary bellows performs preliminary regulation before the wind moves on to the many other bellows. On all the bellows, the hinges and corners (called "gussets") are made from leather, which after 55 years is fatiguing. If this bellows were to fail, the organ would be rendered inoperable, since all the wind flows through it.

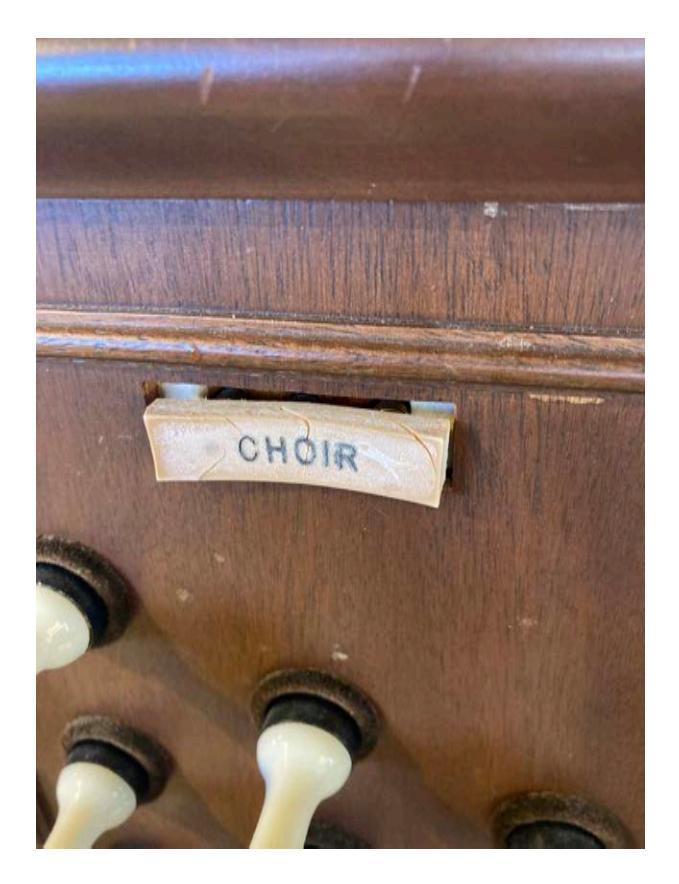
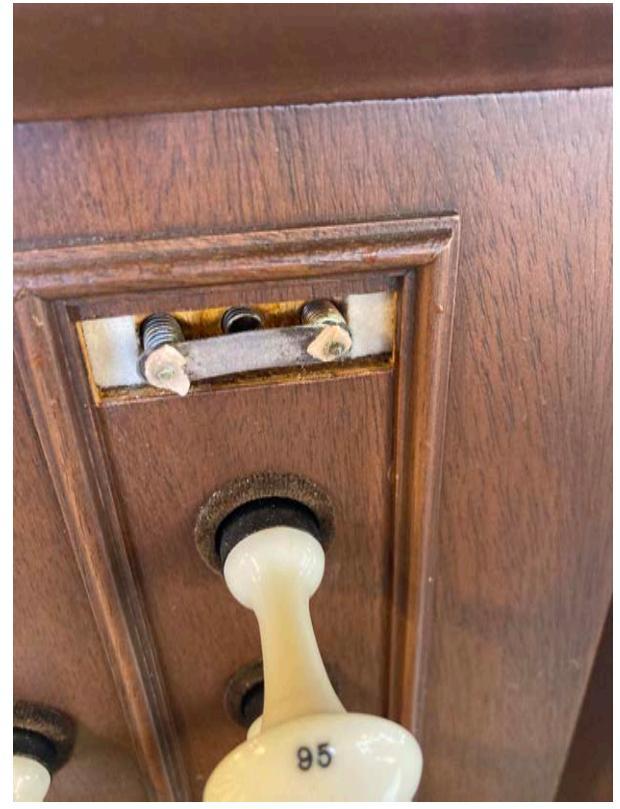
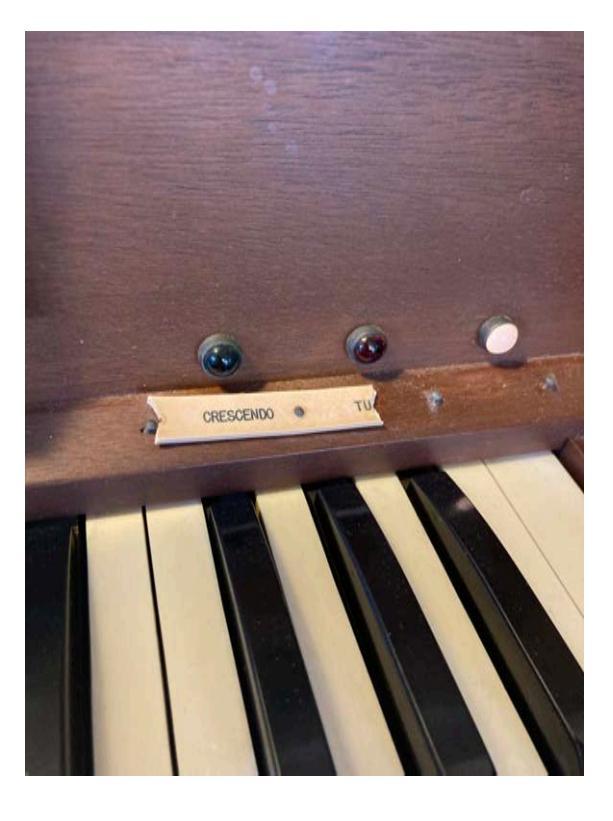
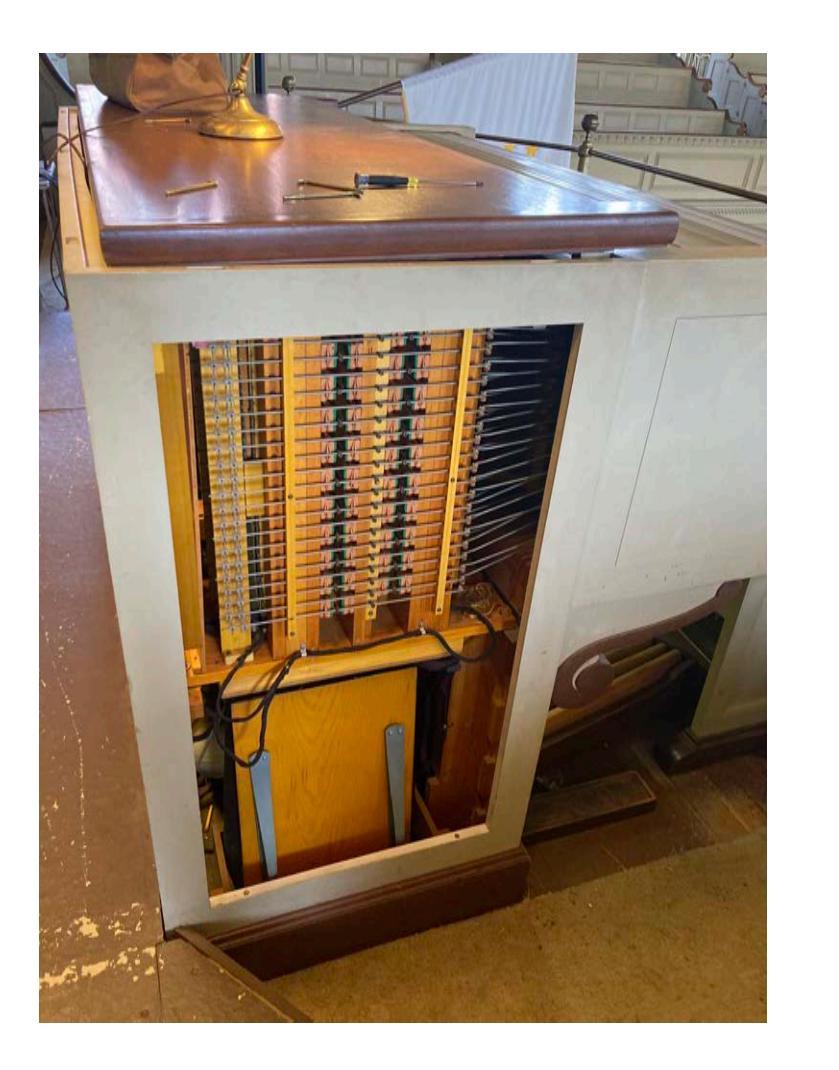
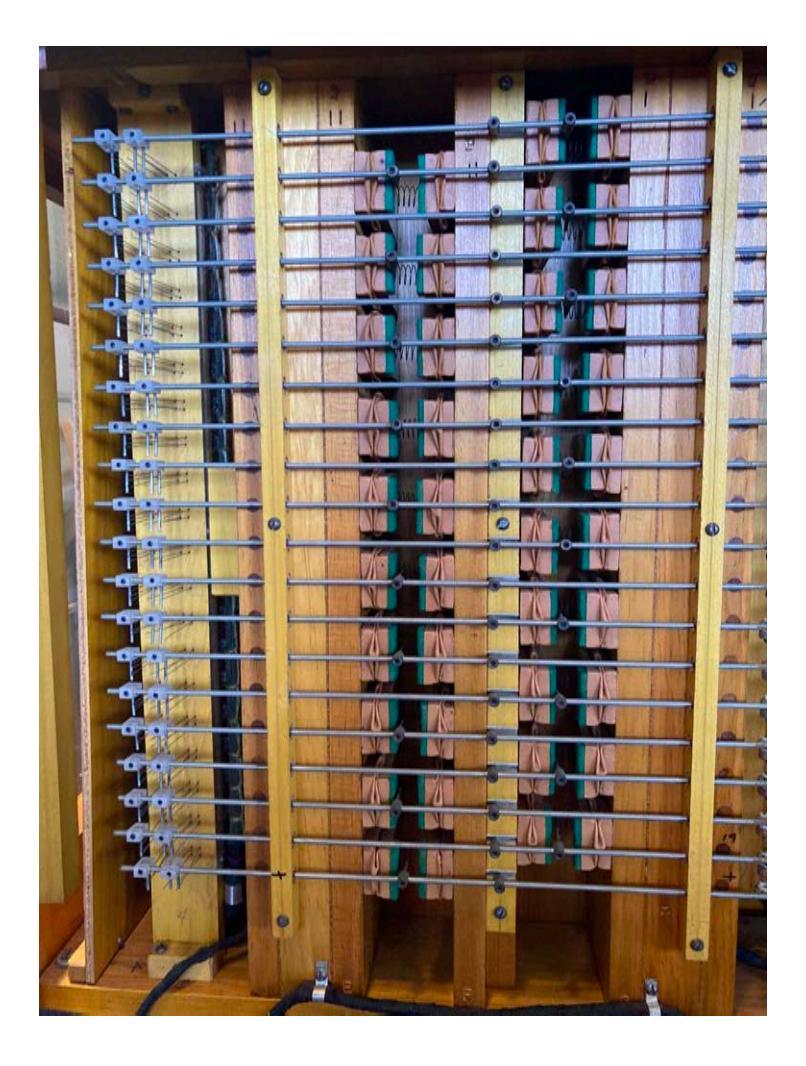
... but those used for labels, less so. The labels above the knob groupings have a secondary function: pressing them cancels all that group's knobs to facilitate quick changes to get, for example, a new solo sound. The entirely failed Positiv label (middle photo) reveals the canceling mechanism behind the now-broken-off label.

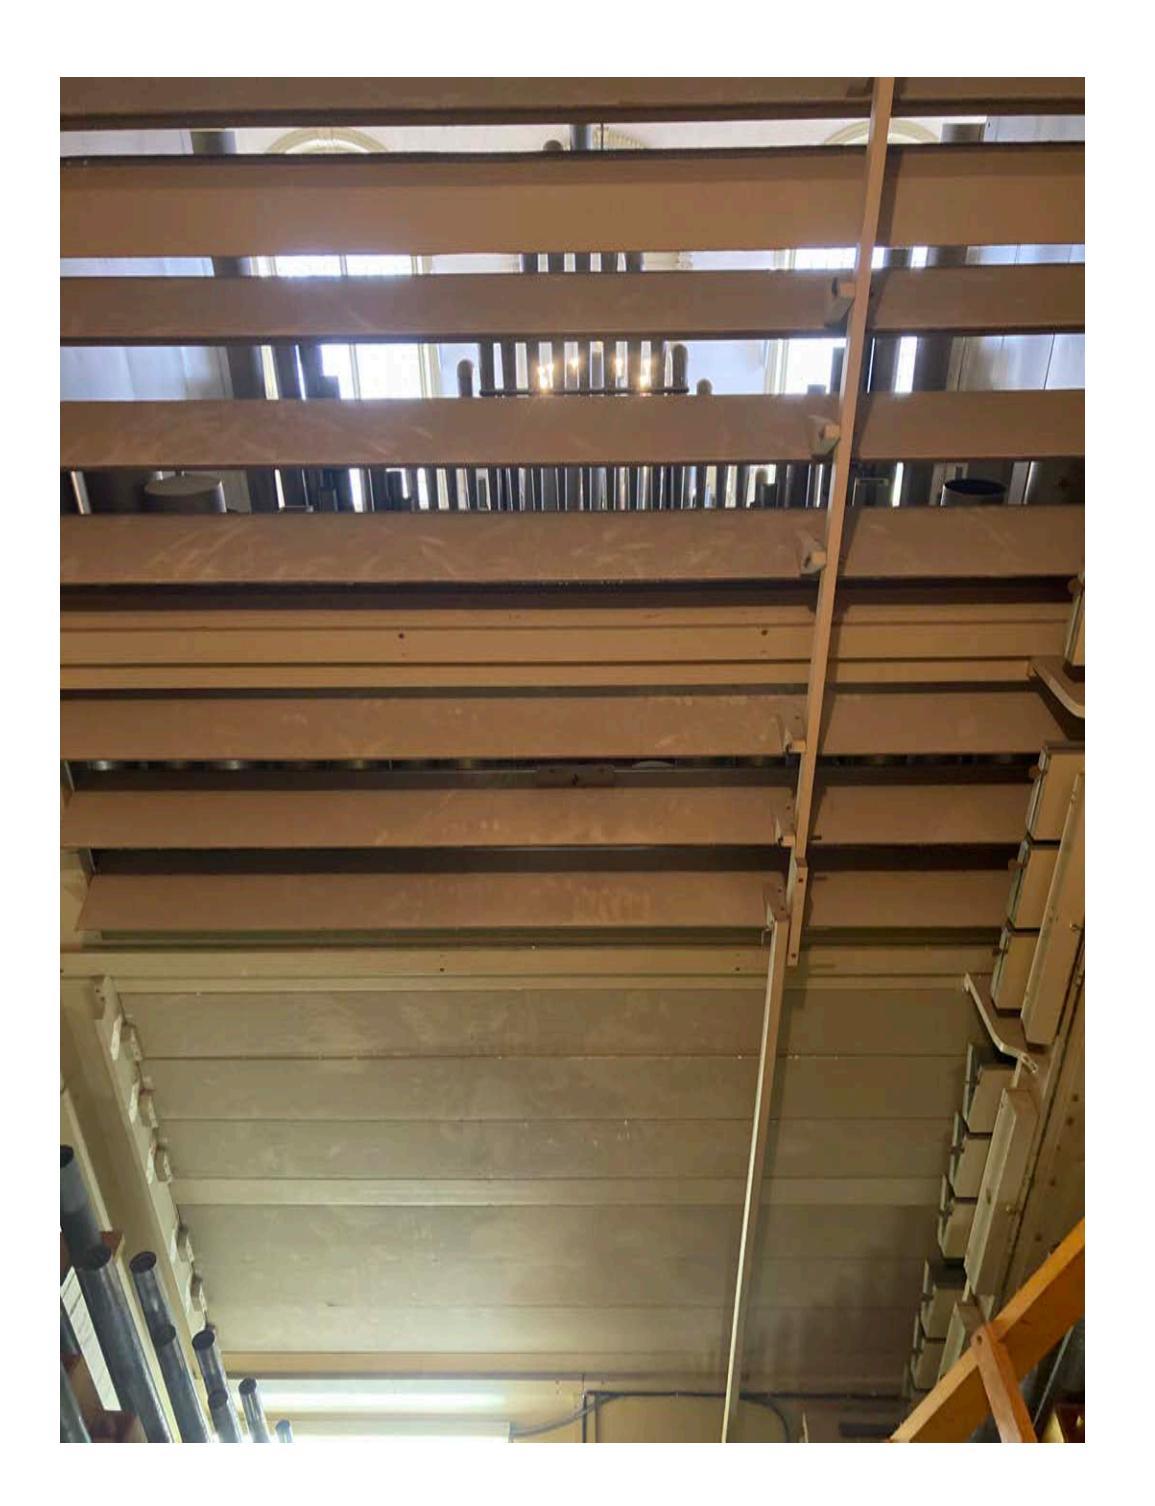
At some point, the lower shutters were de-activated and left permanently closed, while the upper set were made no longer operated individually (one shutter opening at time) and instead ganged together for simultaneous operation.

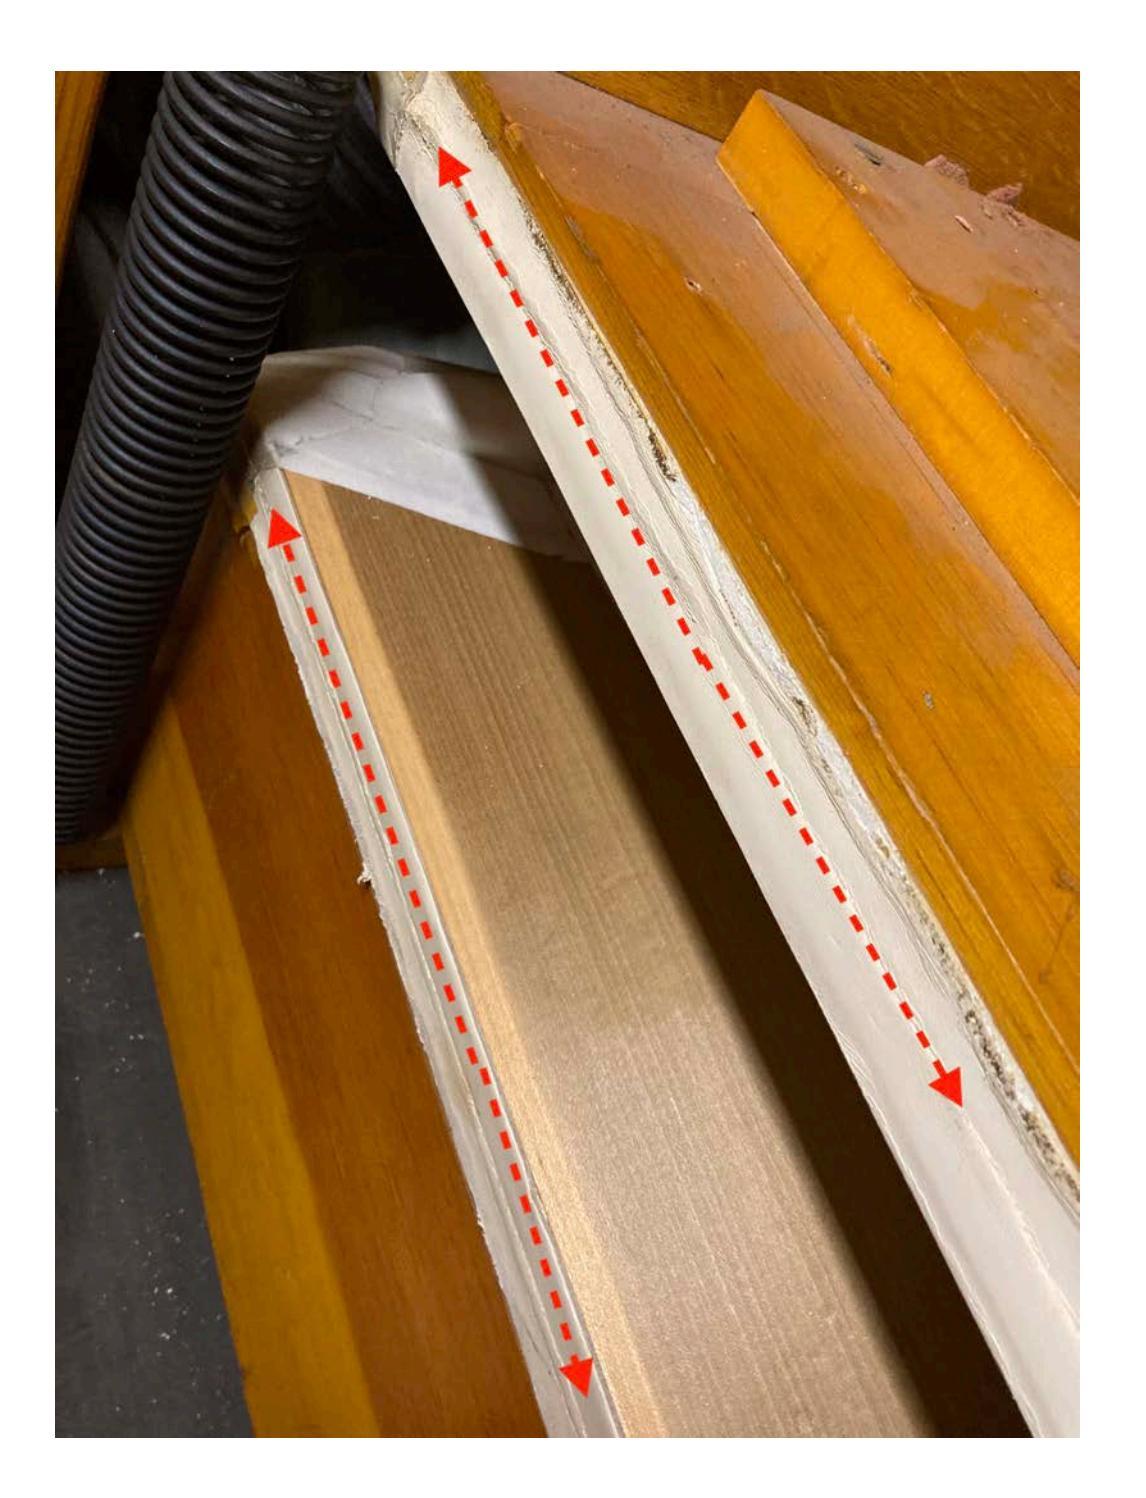
The Swell division alone contains five bellows, all in similar condition the blower's bellows in the tower: failing hinges and gussets.

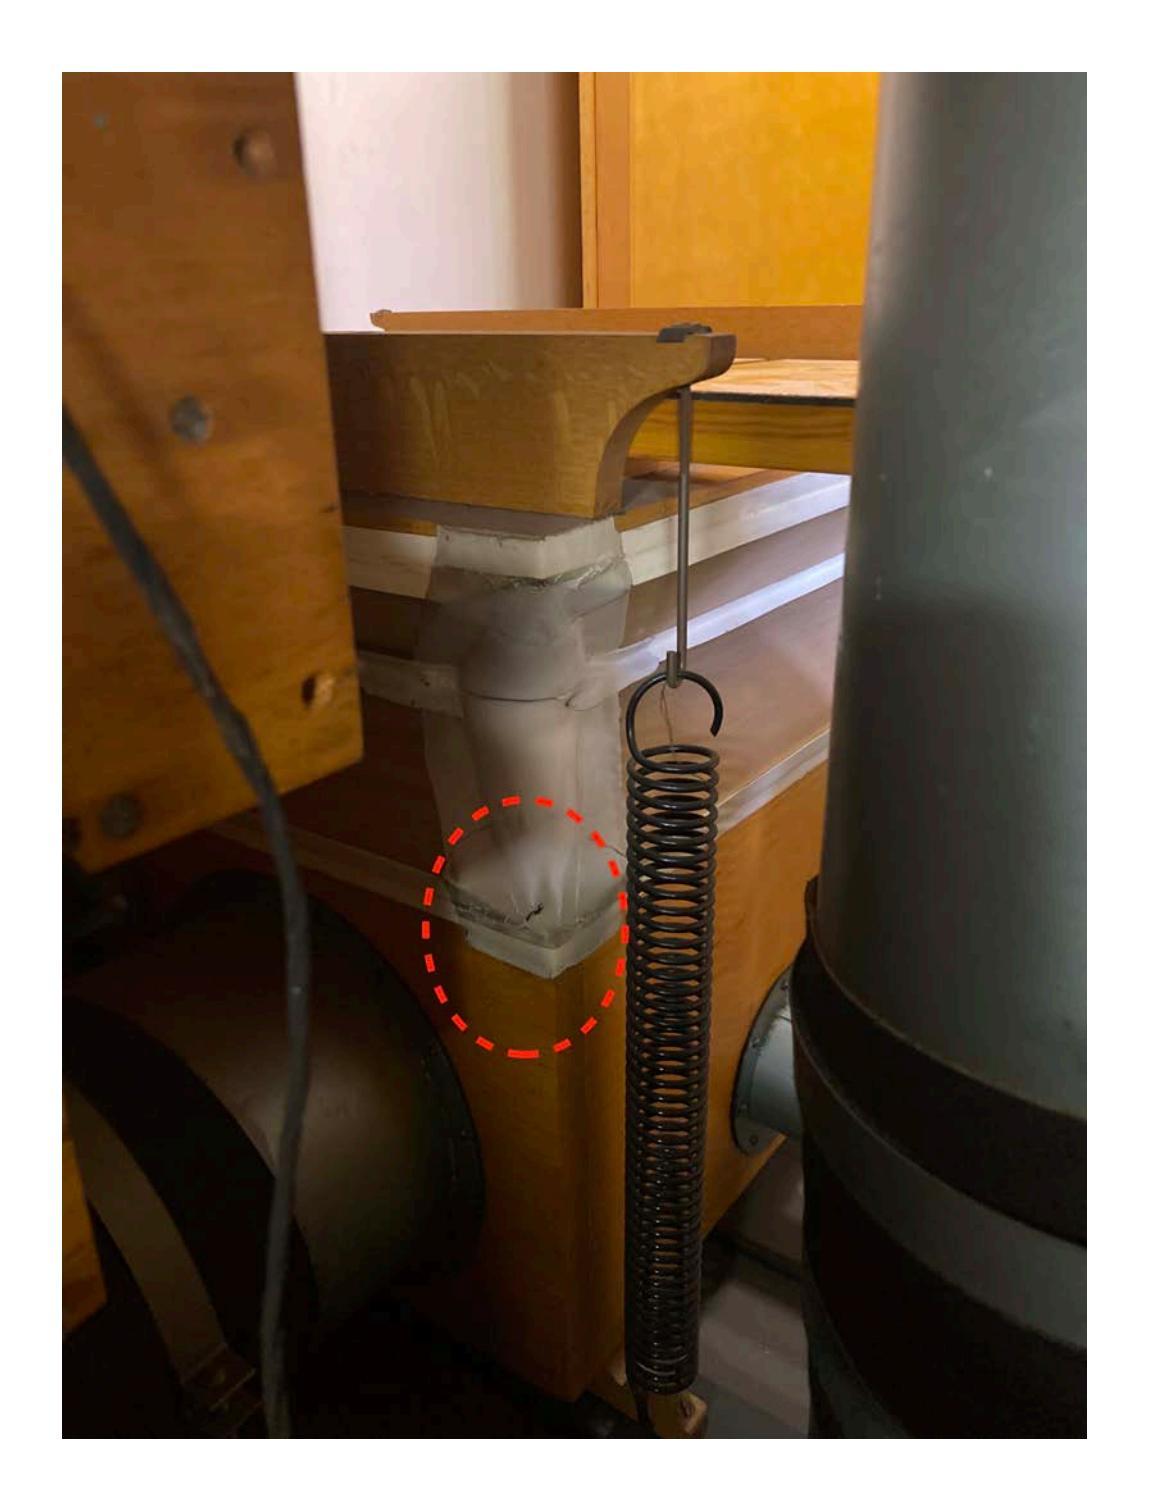
The gussets on this bellows are particularly fatigued, with small holes already developing.

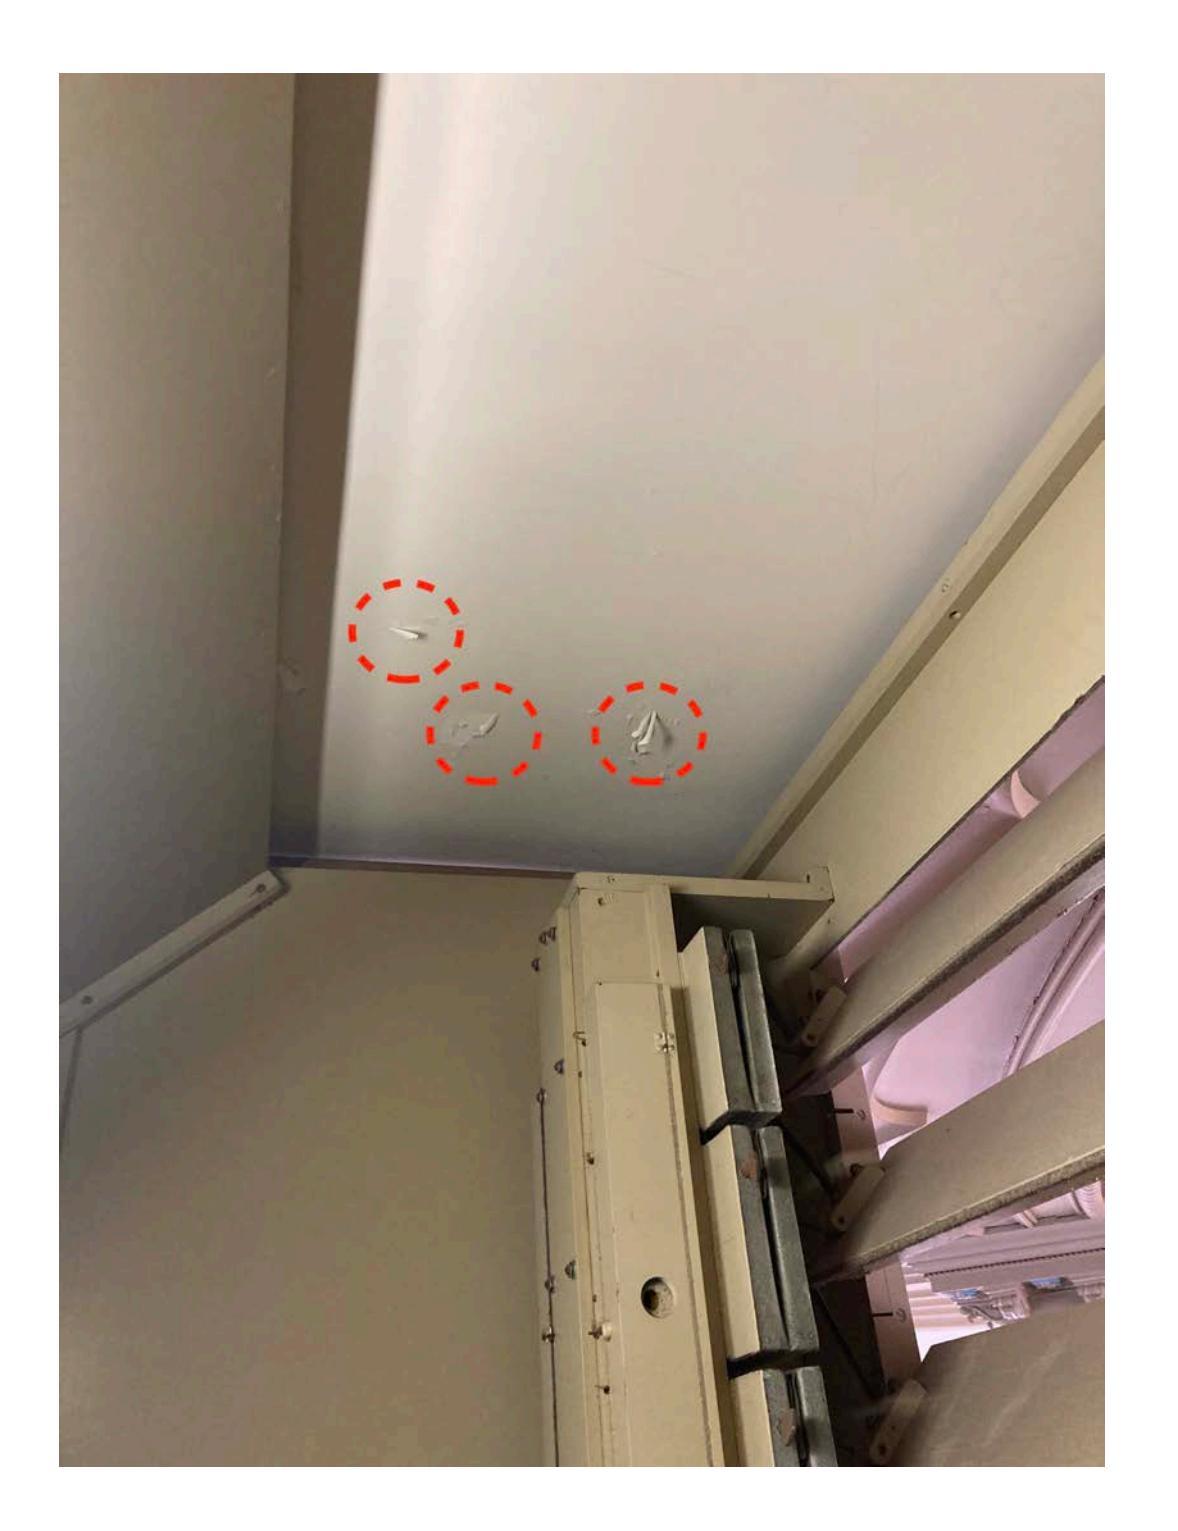
On the ceiling in the Swell, the paint is beginning to flake off. While it looks minor, any particulate matter at risk of falling into the pipes is a liability.

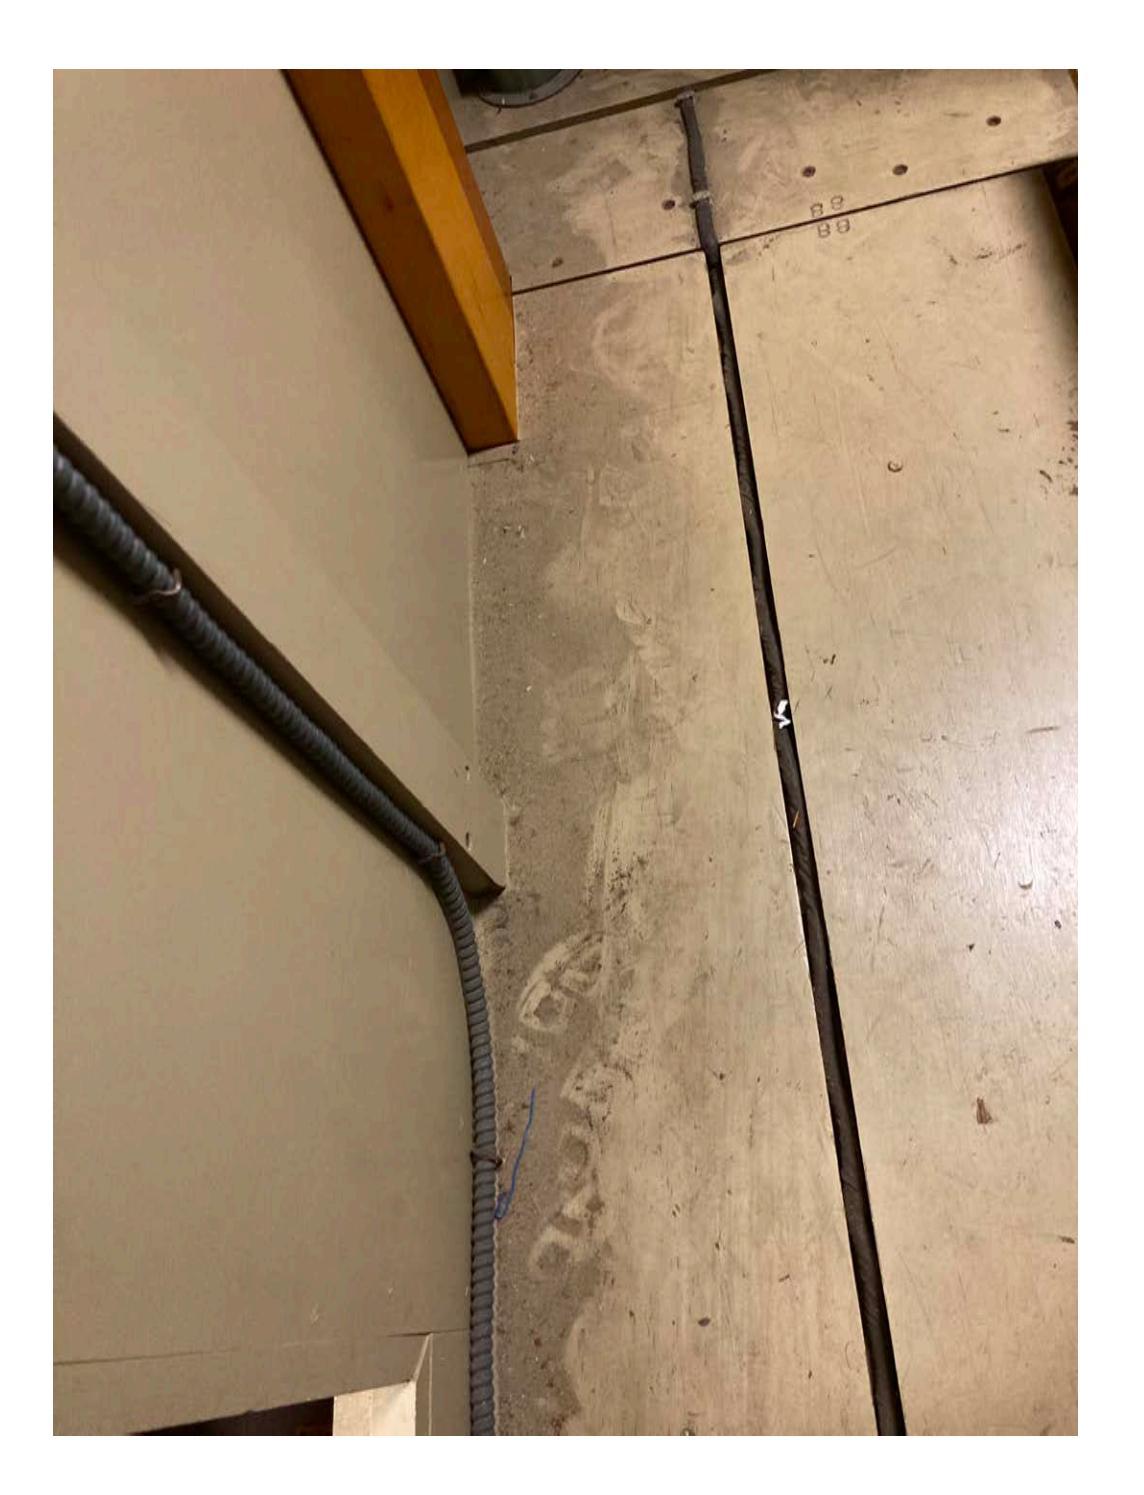
The accumulated dirt, here and elsewhere, tells us something about the organ's standard of care in recent years.

The Choir's four bellows are in a similar state to the others: crumbling leather close to failure.
