FIRST UNITARIAN CHURCH OF PROVIDENCE One Benevolent Street Providence, Rhode Island 02906

> 24 JUNE 2023 Rev. 24 July 2023 Rev. 30 July 2023

THE 1968 M.P. MÖLLER PIPE ORGAN

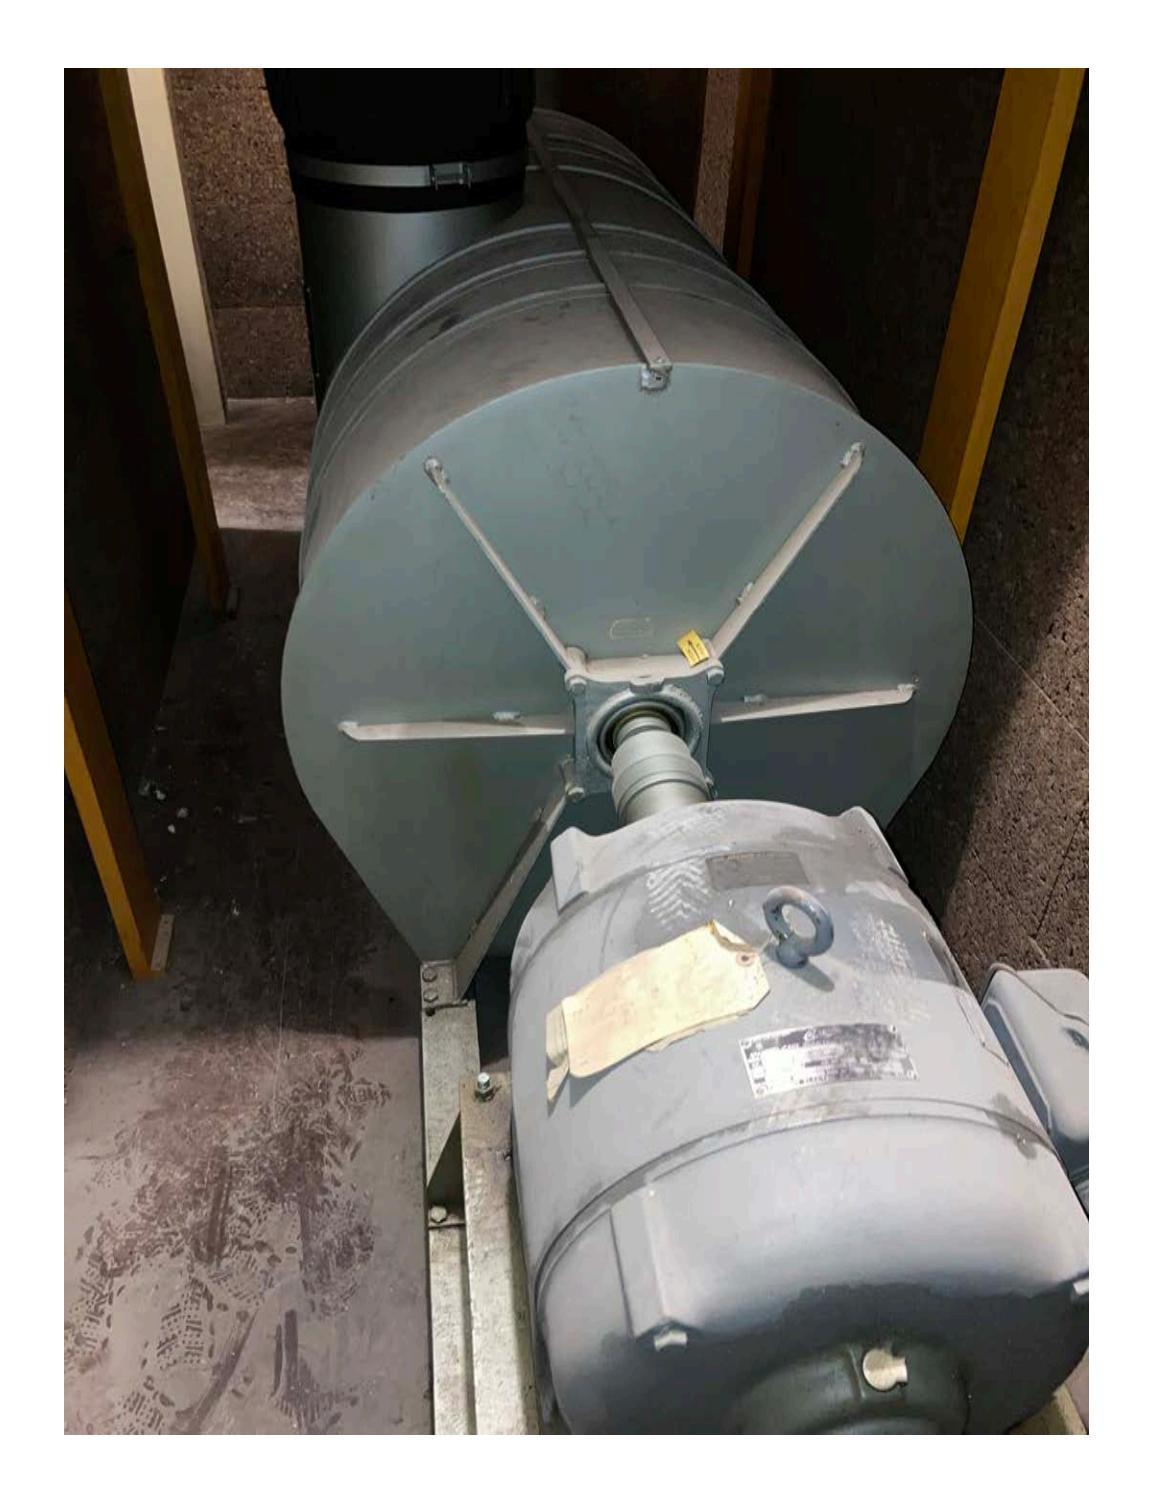
Often we think of a pipe organ as its console and pipes. And yet, a critical component is the device that generates the pressurized air, or "wind."

Organ blowers are like giant turbine vacuum machines operating in reverse. The motor is external, so that it can be inspected and regularly lubricated.

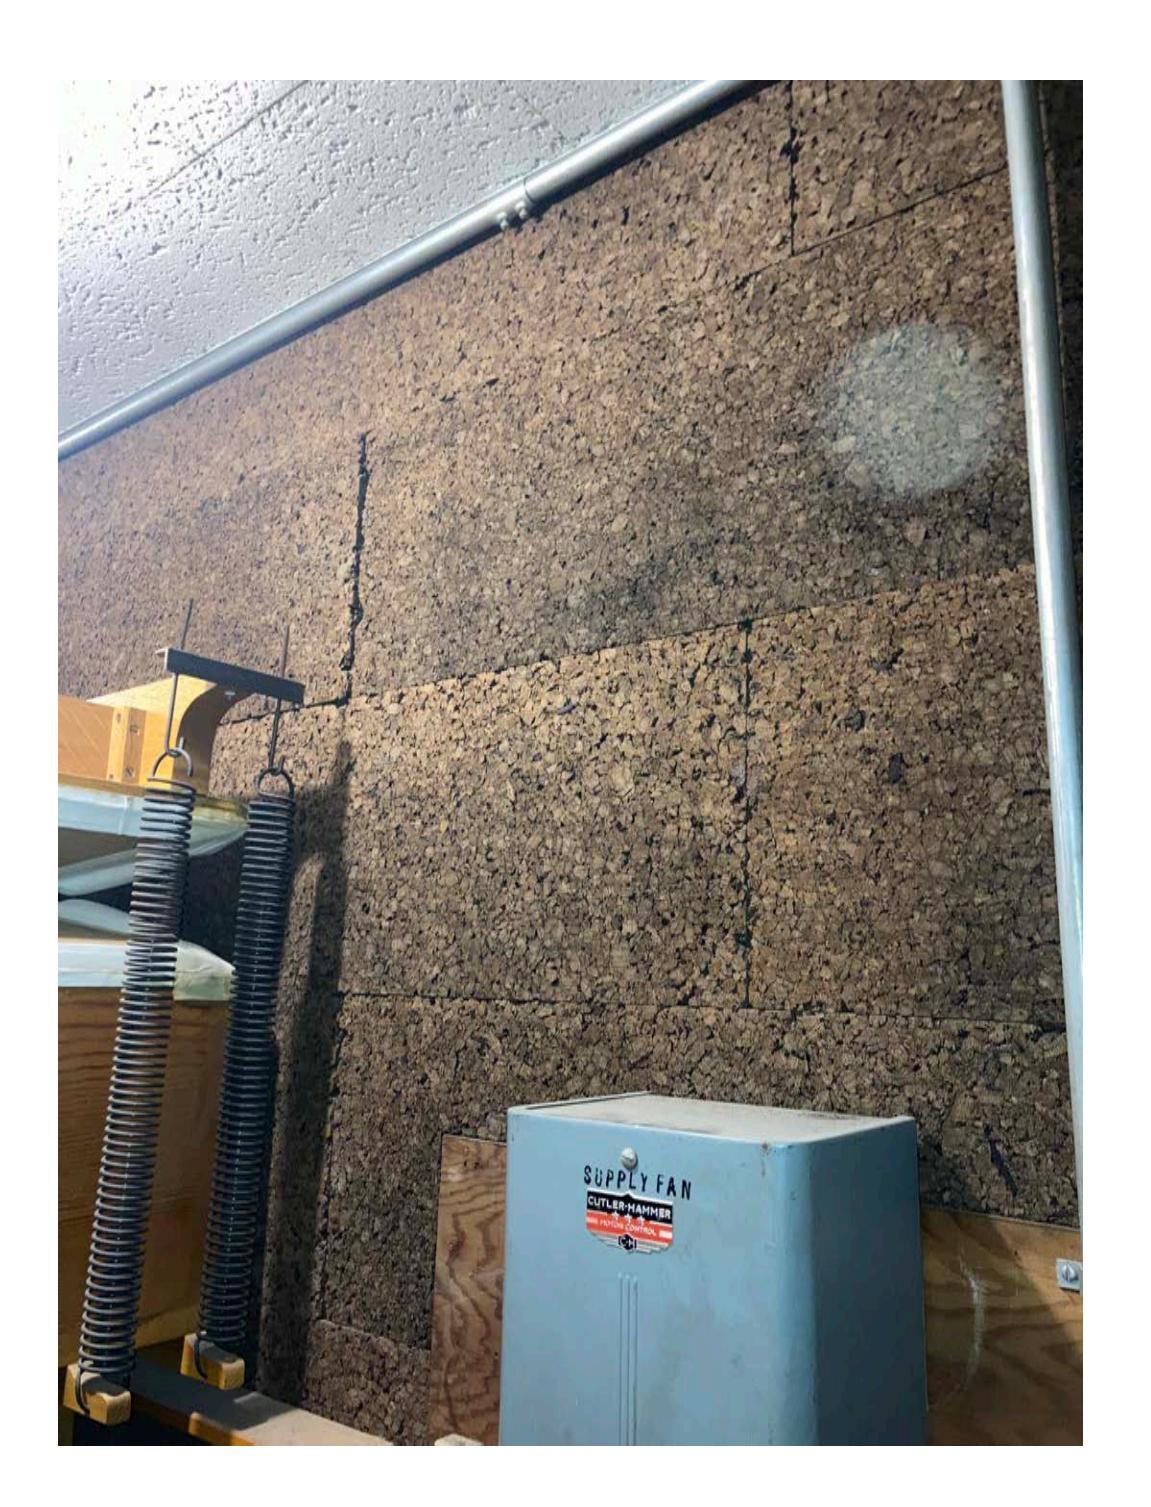
Given the noise of the blower, its enclosing room is lined with cork to absorb sound.

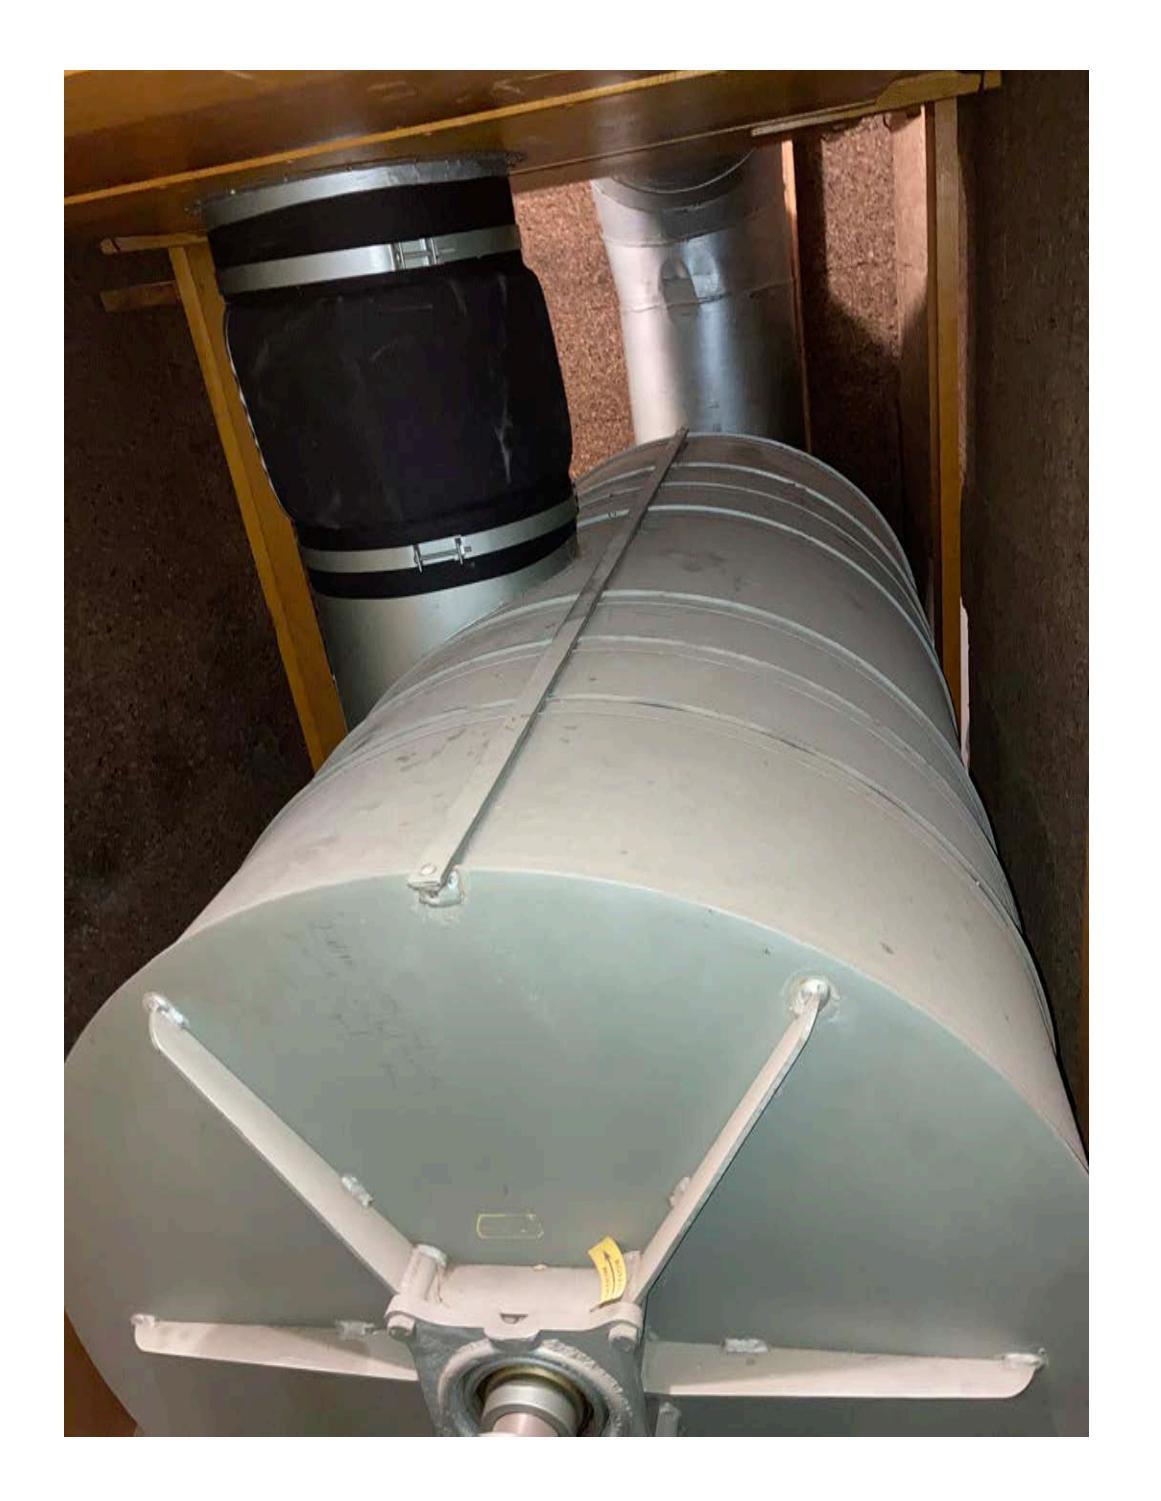
Multiple fans within the turbine generate the wind, which is then conveyed to the pipes and wind-operated mechanisms.

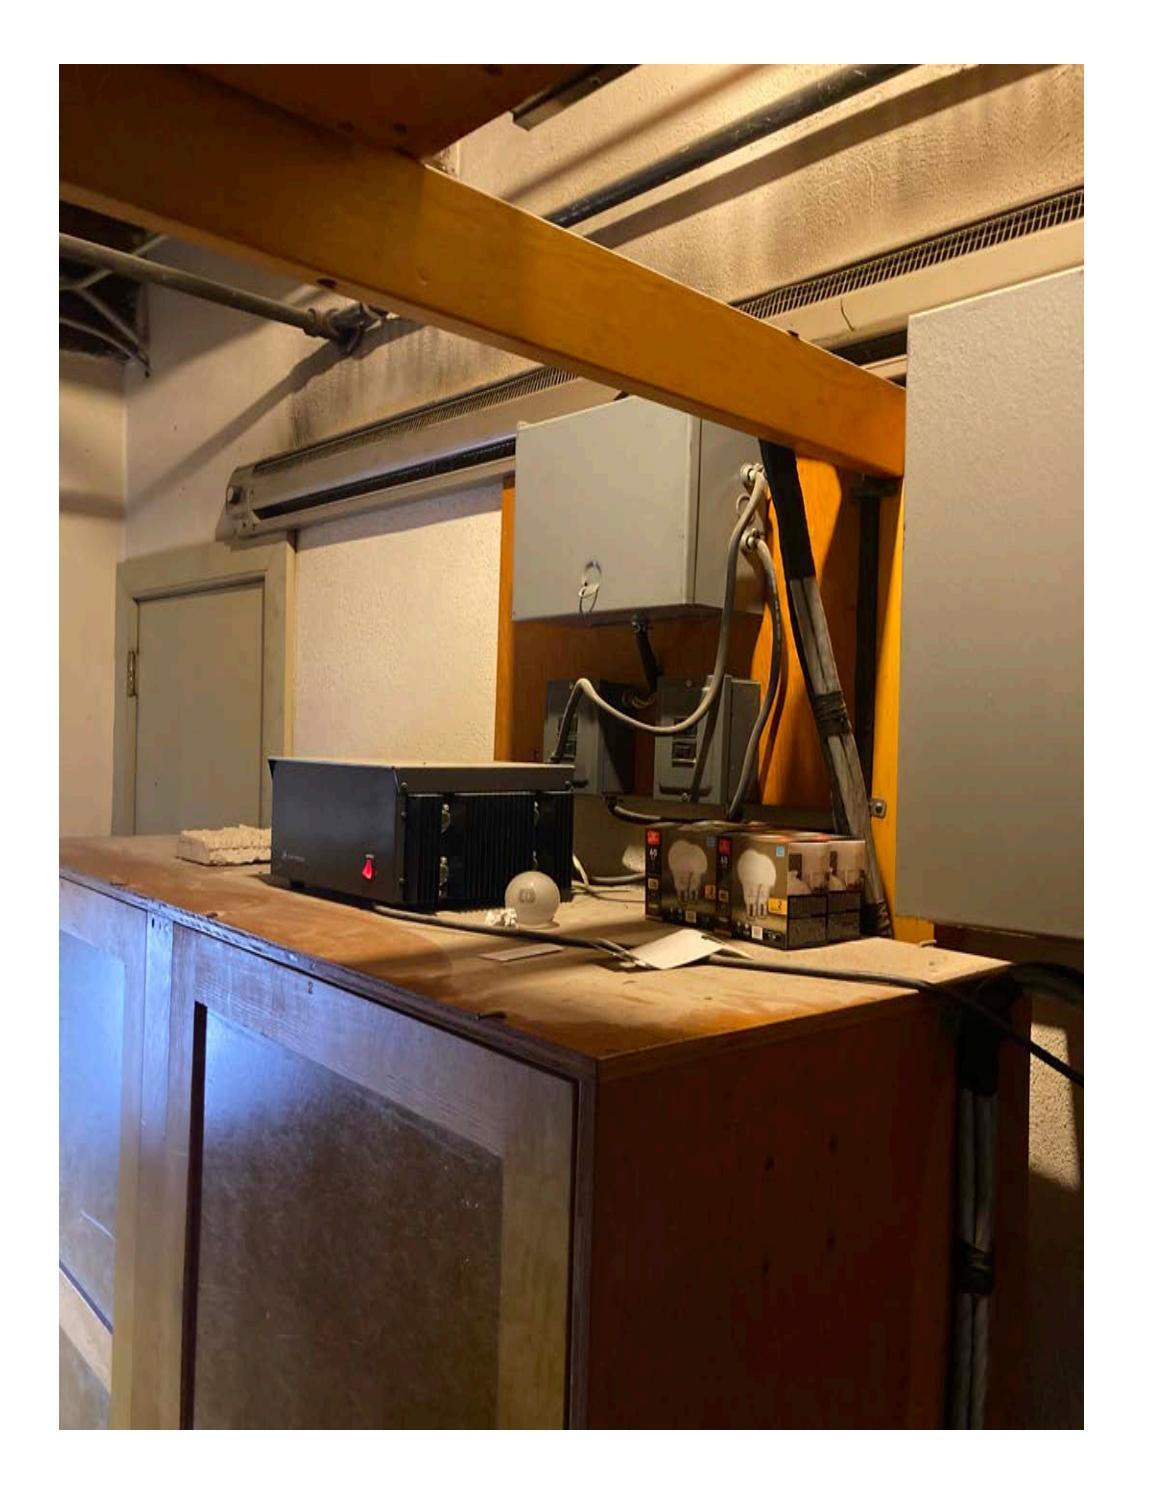
Outside the blower room are cabinets containing various electro-mechanical switching units. In effect, this is large mechanical memory bank for the preset buttons in between the keys. Today, solid-state electronics would accomplish all this in something the size of a wallet.

The black box here is a low-voltage power supply, superseding the original. The organ's electric action works on 12 volts direct current, like an automobile.

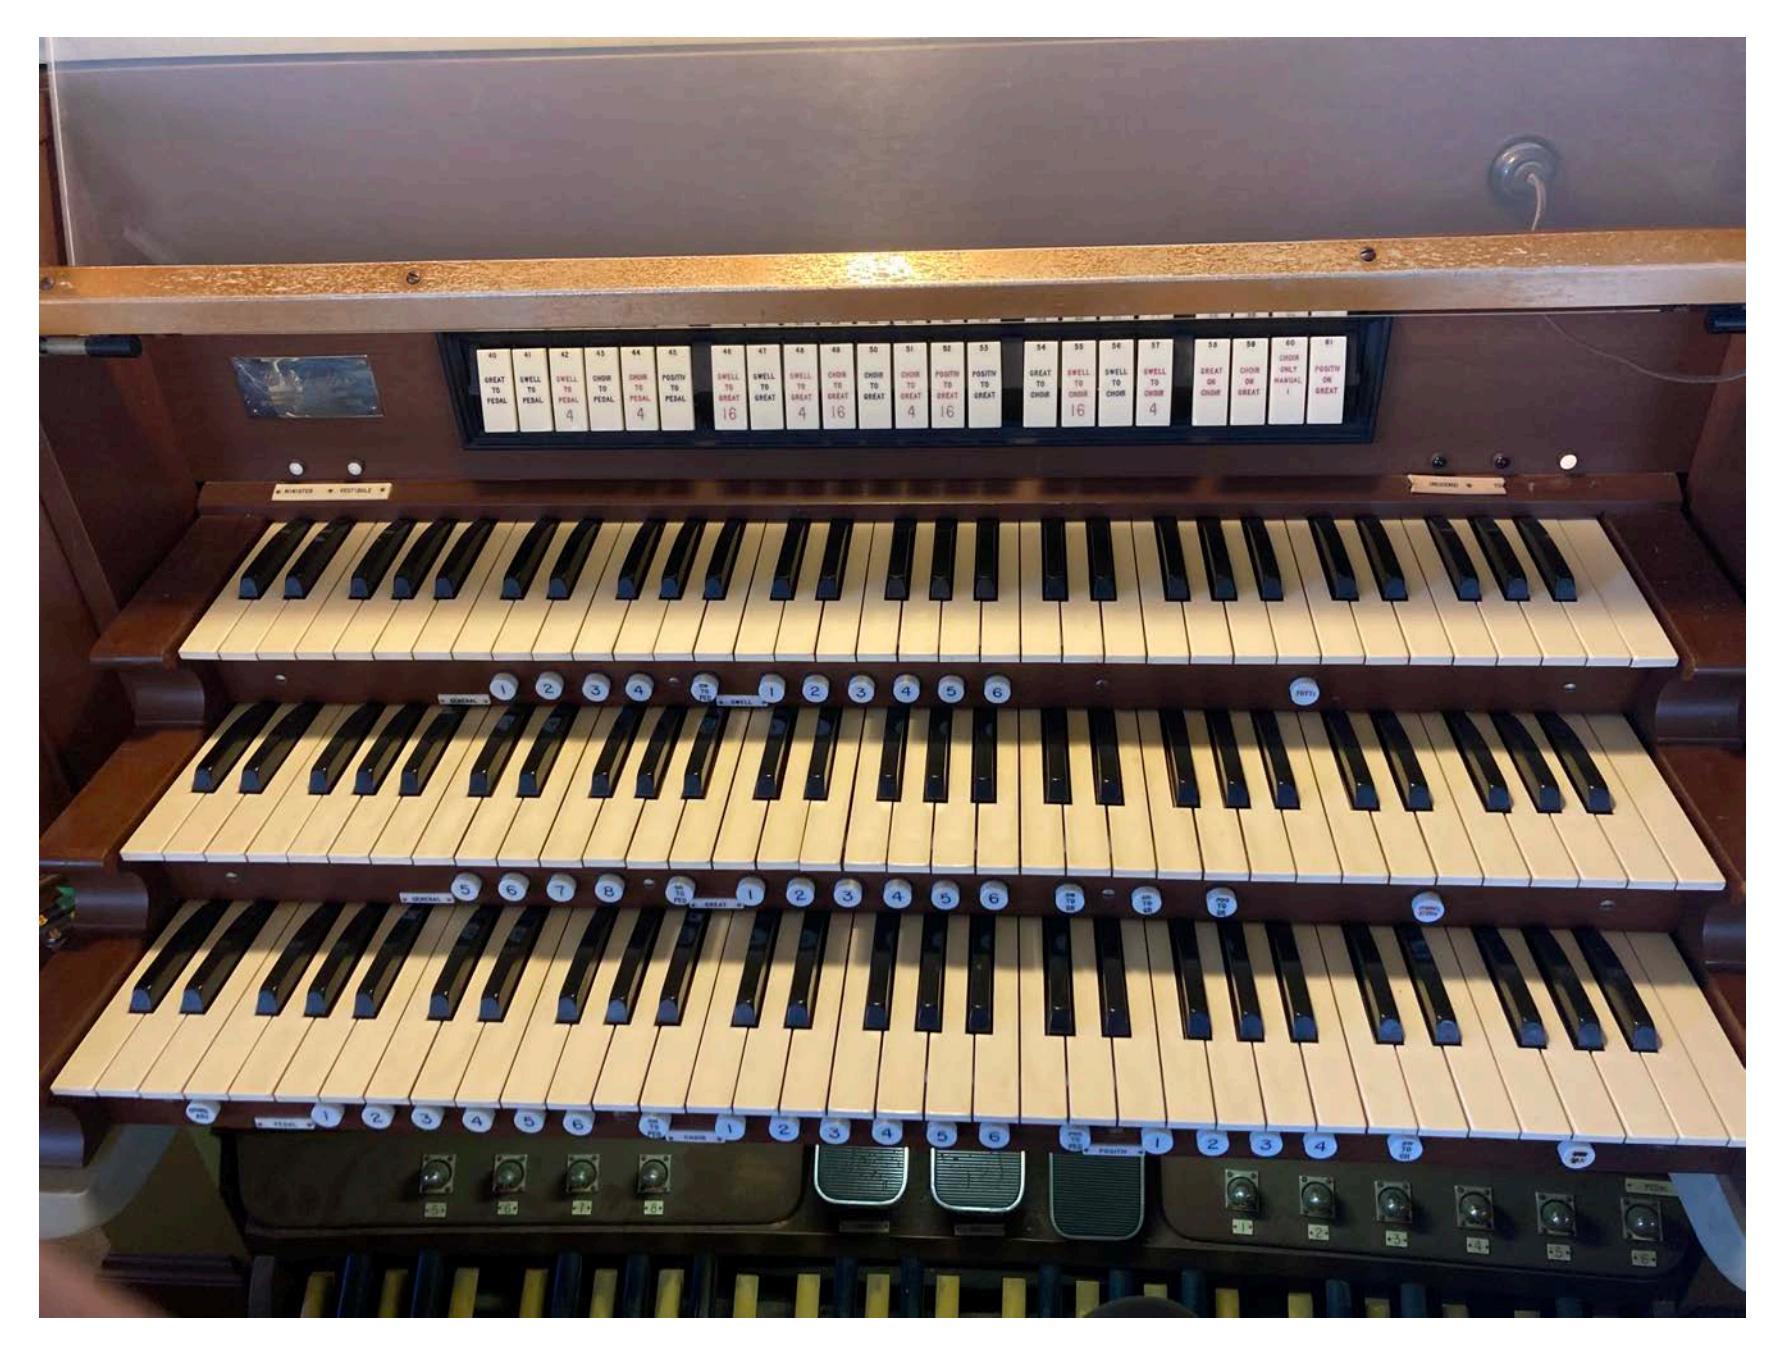
Moving downstairs to the organ loft, we see the console showing signs both of resilience and age.

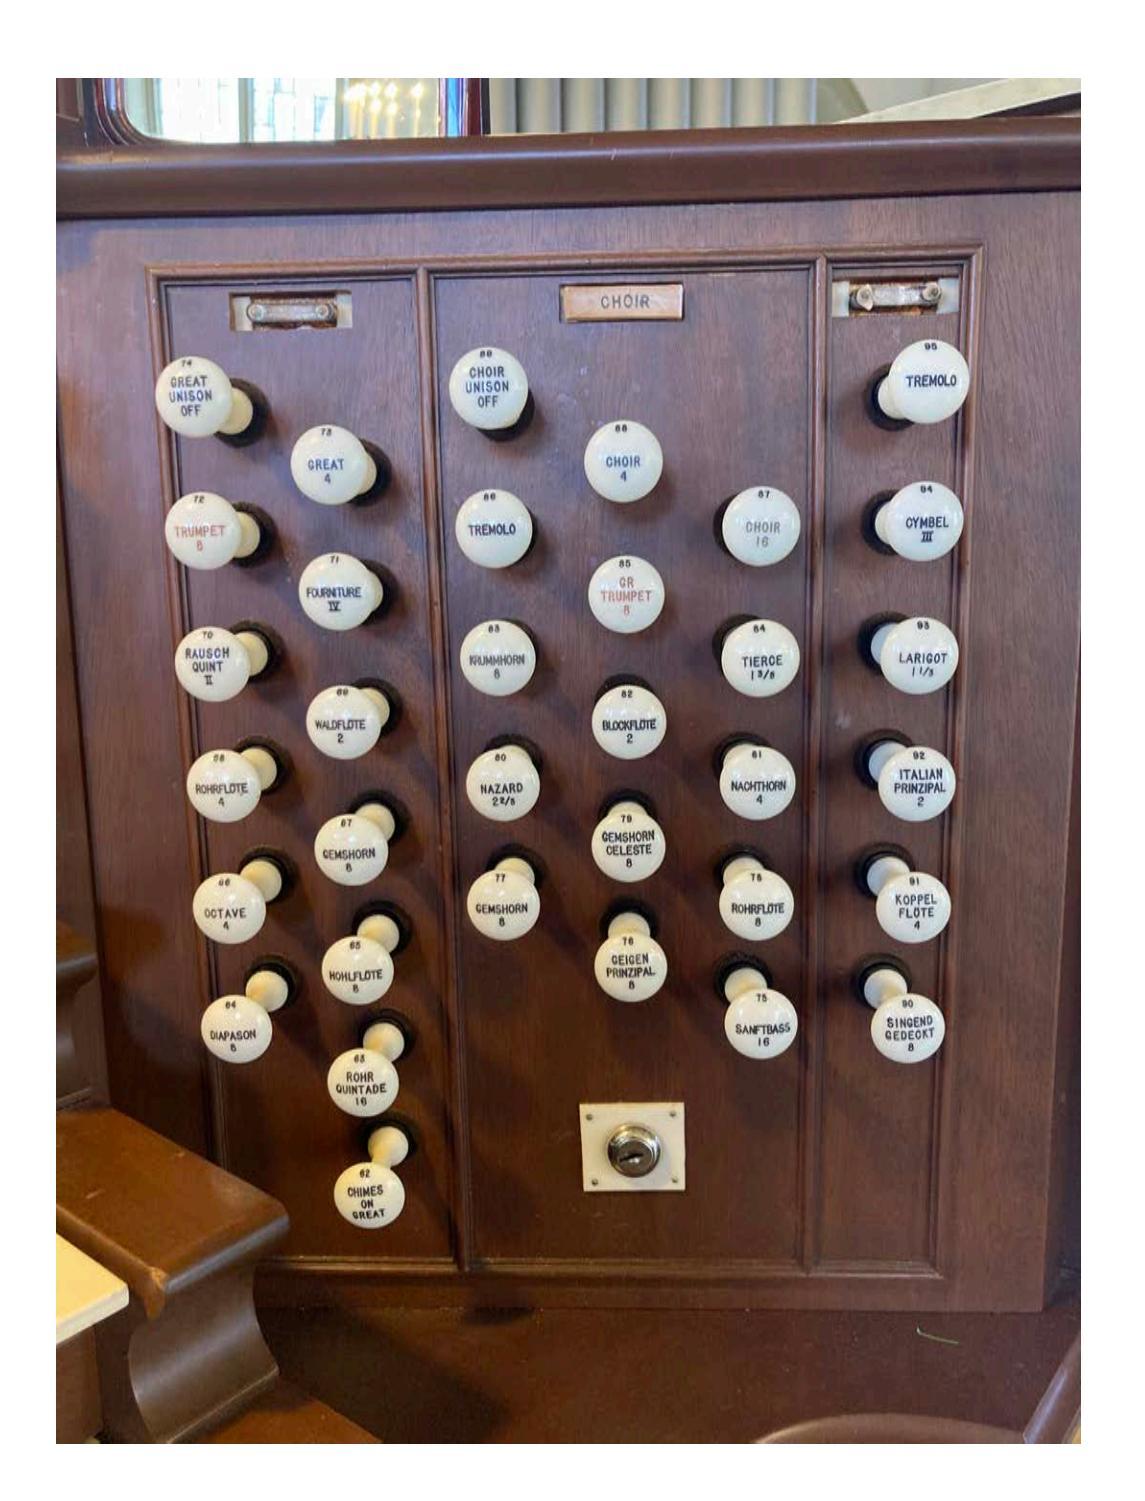
Möller consoles from this period use two different kinds of plastic. The variety used for drawknobs and tilting tablets has aged well...

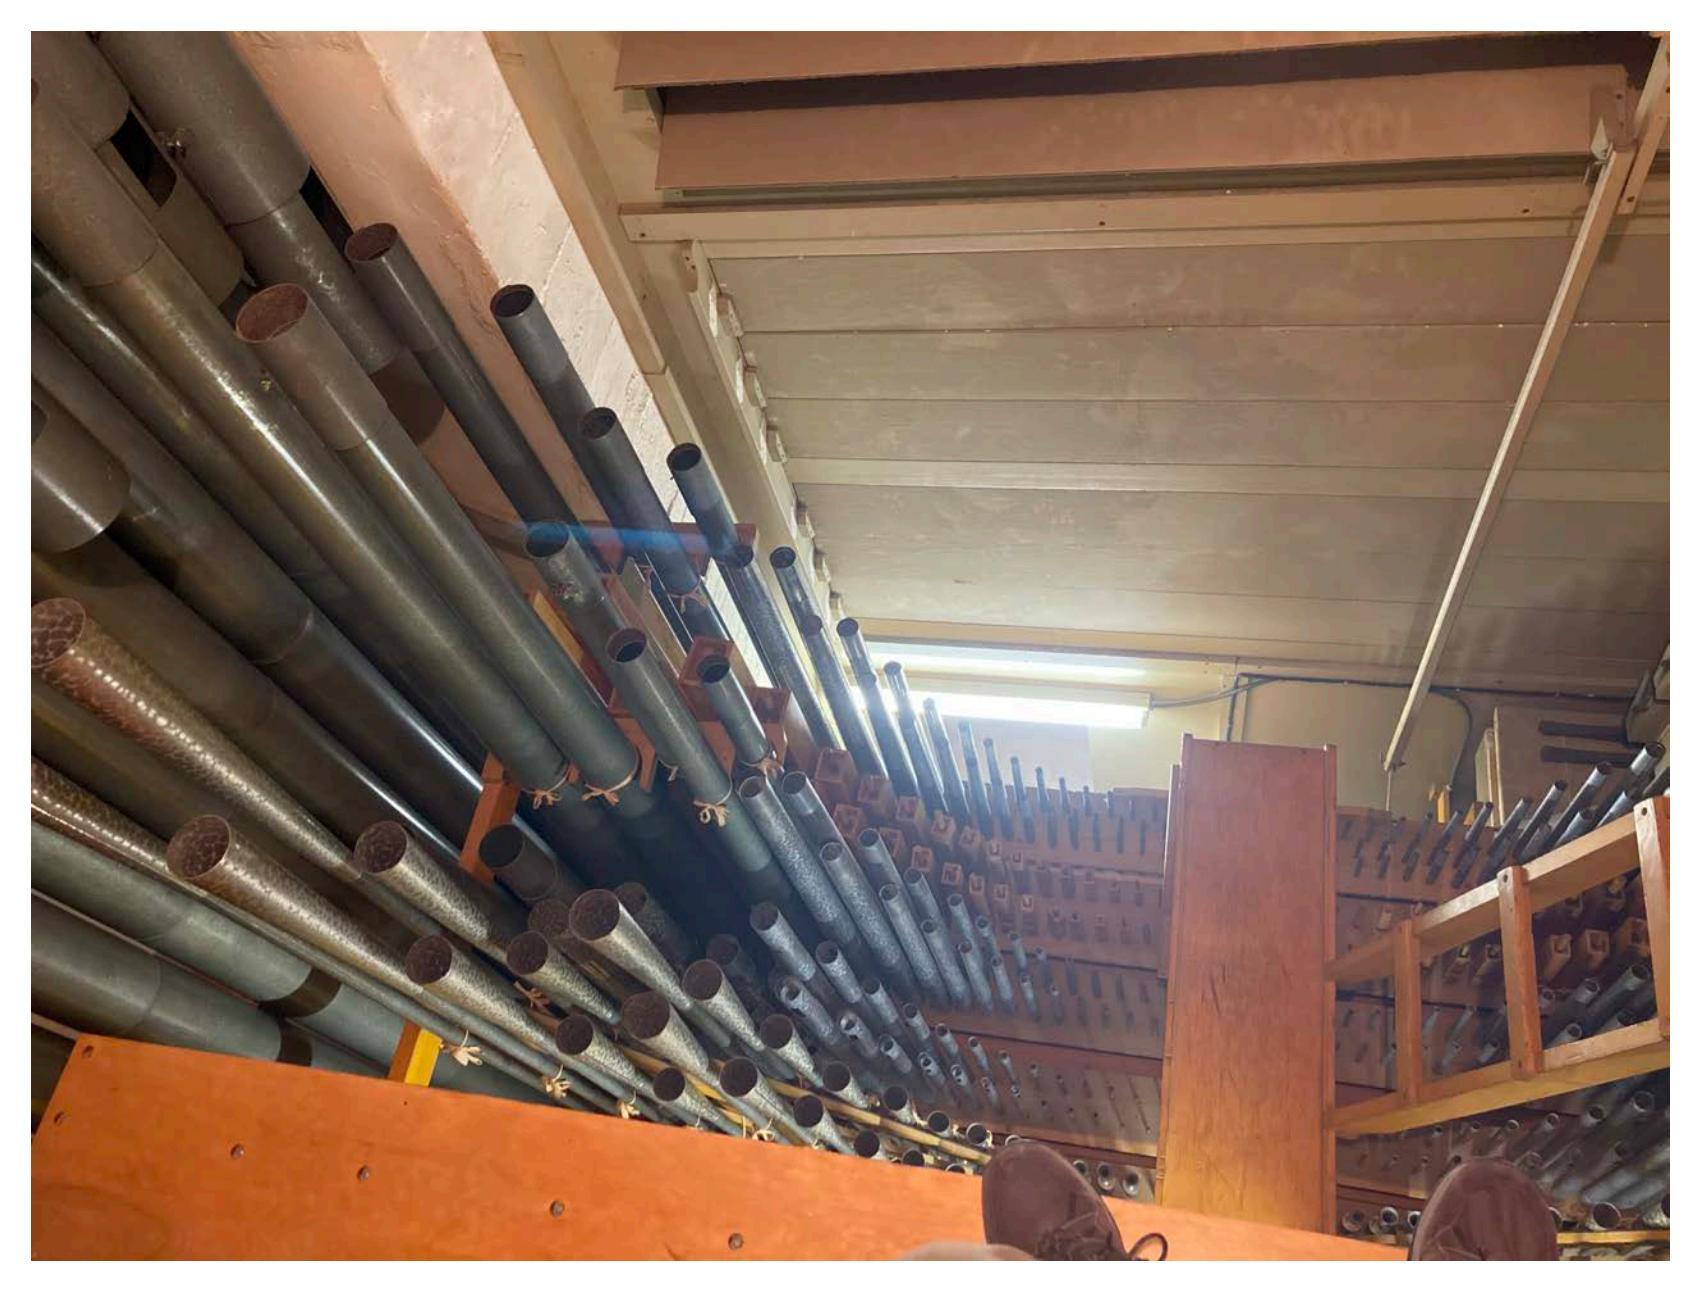
We are now inside the organ's central rear section, called "Swell." In this section, pipes are contained behind a wall of louvers, called "swell shutters." They open and close to control the volume of the pipes within.

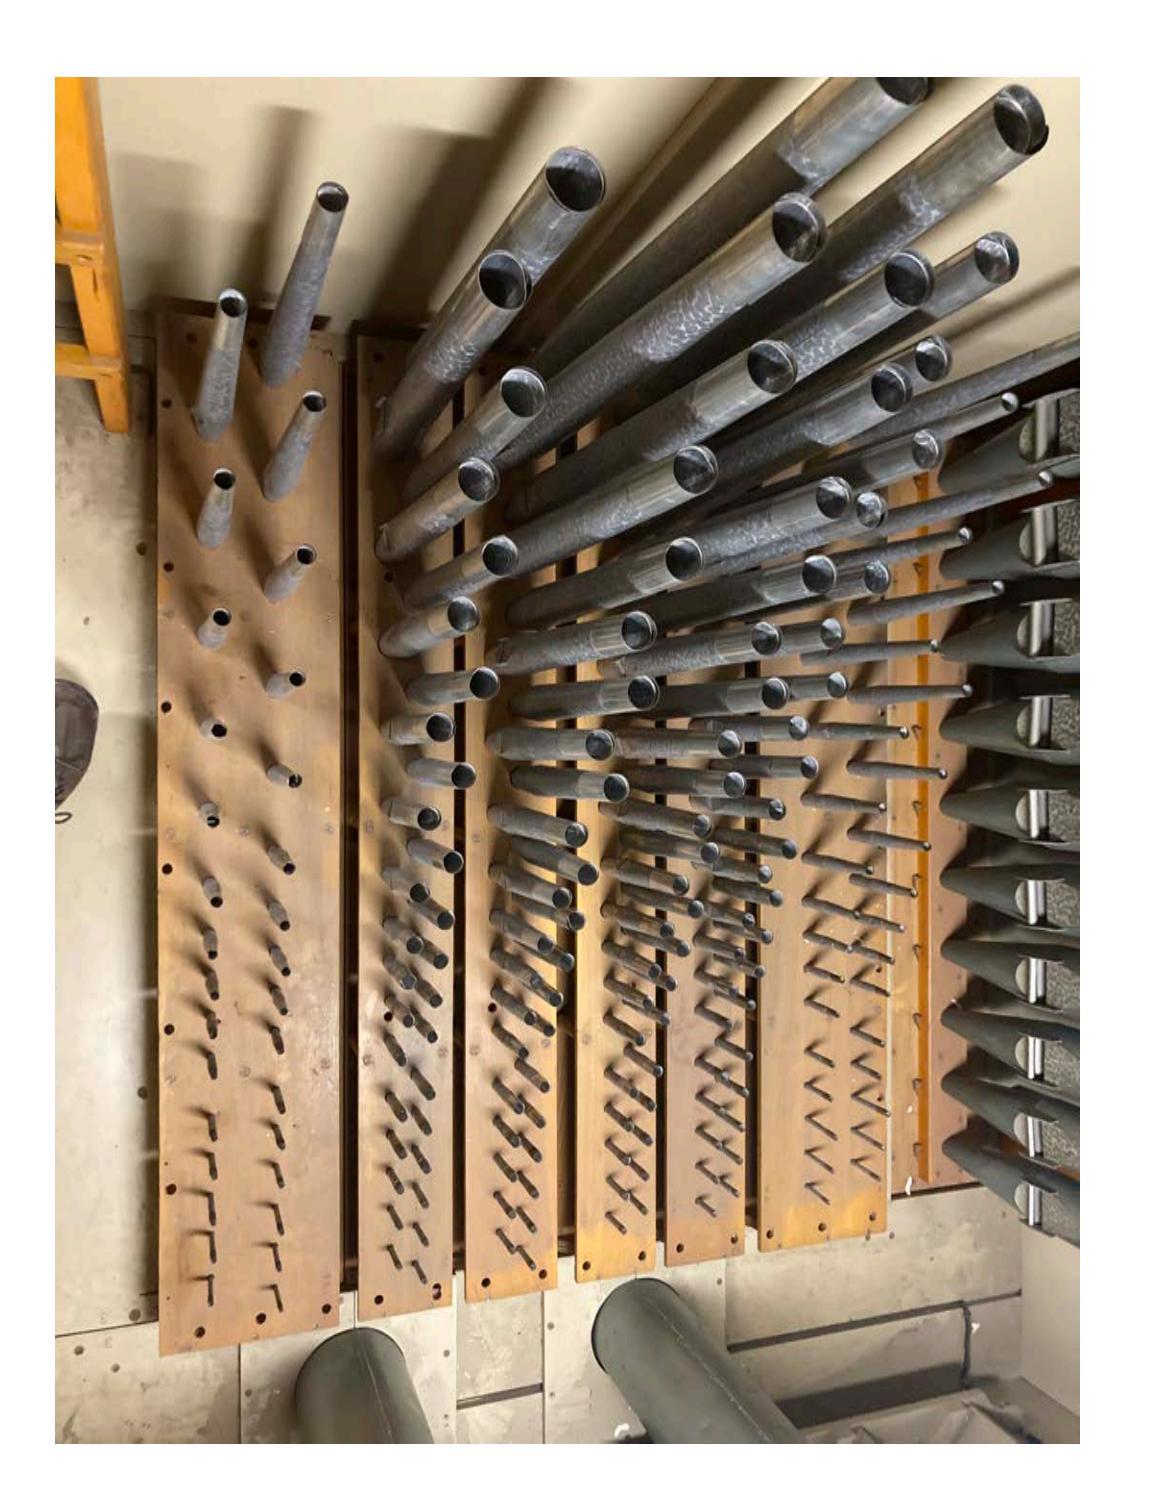
The Choir division is housed within two separate enclosures to either side of the Swell. The shutters here are vertical, unlike the horizontal ones of the Swell.
